Maumee River (lower) Tributaries and Lake Erie Tributaries Watershed TMDL Report

ML/LE Tributaries Watershed TMDL Report

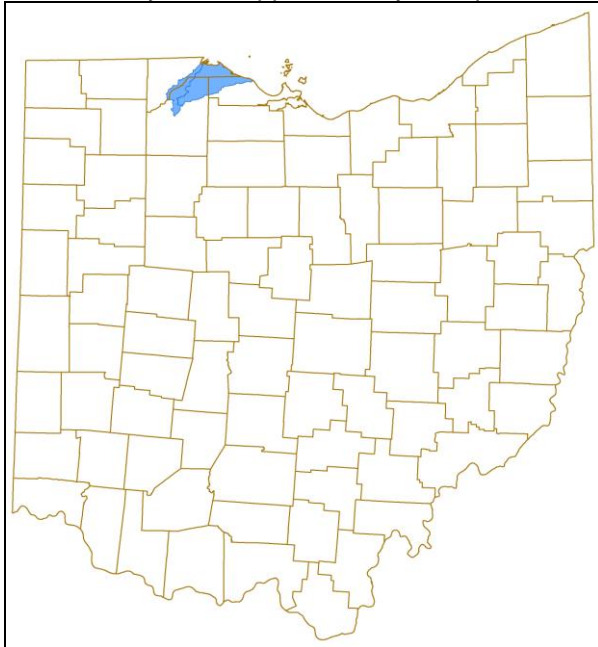
The Maumee River and Lake Erie tributaries are located southeast of Toledo. The Maumee River (lower) tributaries, which drain into the Maumee River and Maumee Bay, drain approximately 77 square miles.

The Lake Erie tributaries, which drain to Lake Erie, drain approximately 205 square miles; all are part of the Maumee Area of Concern (AOC). The watersheds are located in Lucas, Wood and Ottawa counties.

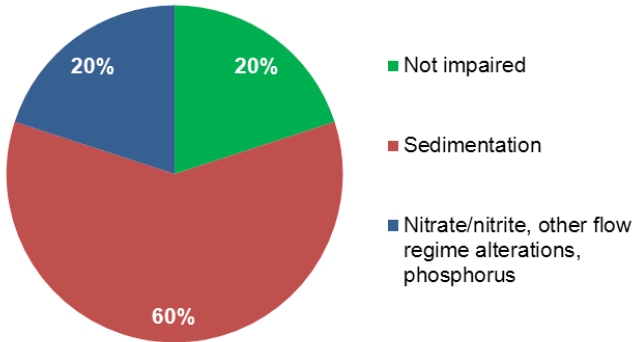
**Maumee River (lower) Tributaries (04100009 09)
Causes of Aquatic Life Use Impairment**

Sources of Aquatic Life Use Impairment

- Urban runoff / storm sewers
- Channelization

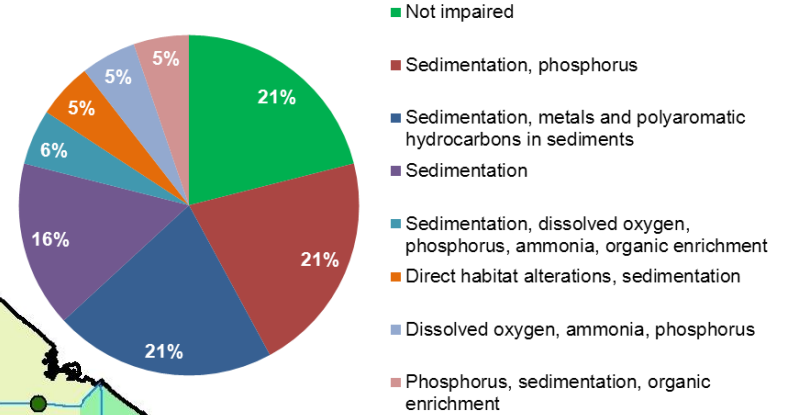
**Lake Erie Tributaries (04100010 07)
Causes of Aquatic Life Use Impairment**

Sources of Aquatic Life Use Impairment

- Non-irrigated crop production
- Channelization
- Urban runoff / storm sewers
- Failing HSTS
- Industrial runoff
- Industrial landfills
- Contaminated sediments

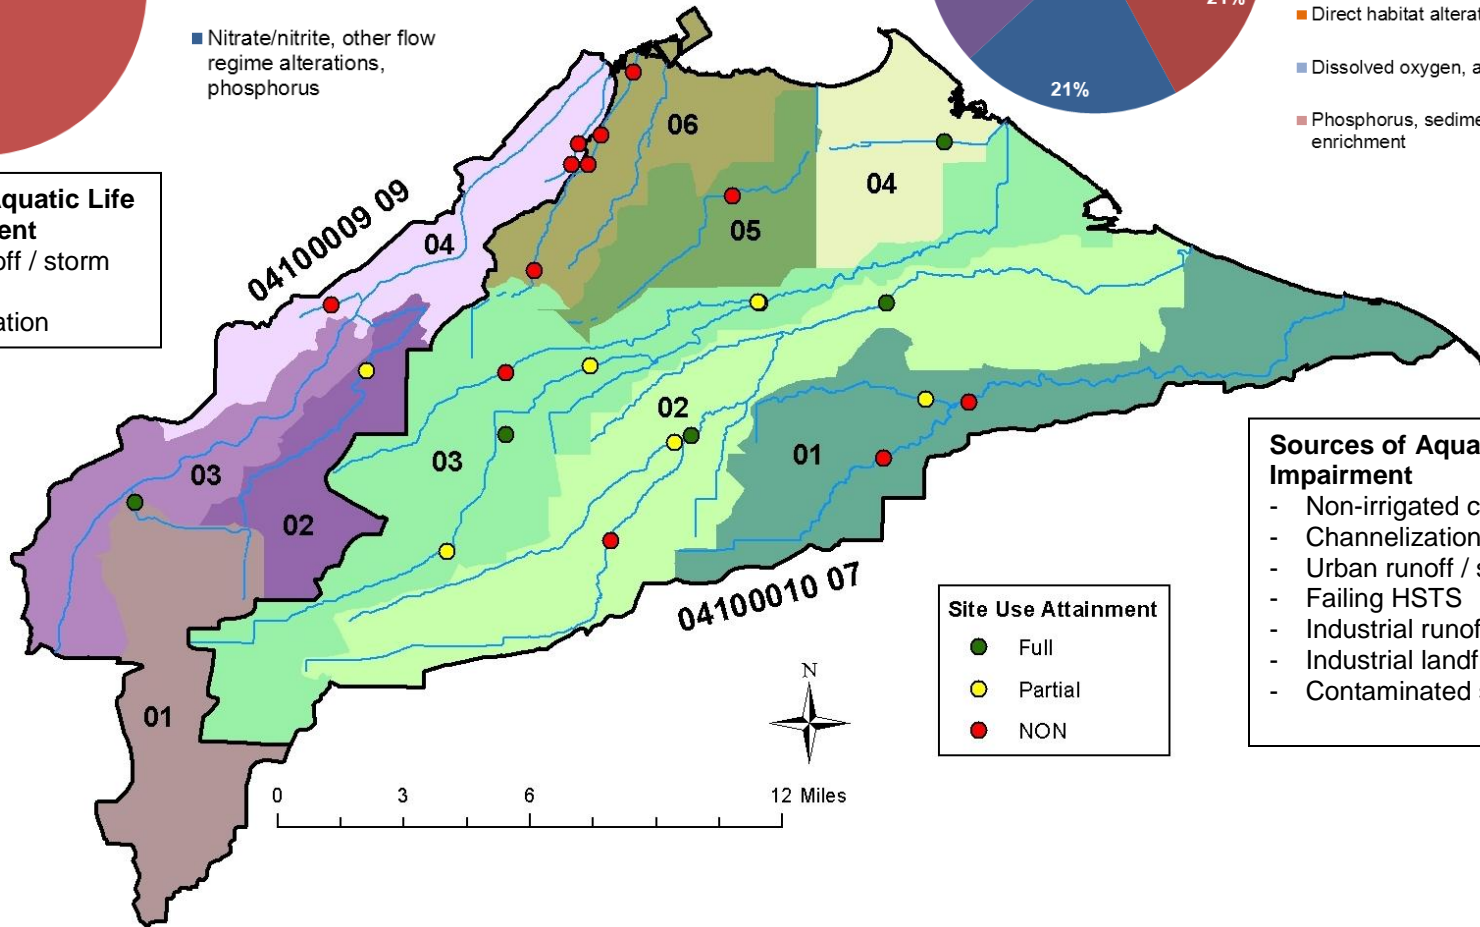
Site Use Attainment

- Full
- Partial
- NON

Twenty-one percent of sites sampled in 2006 and 2008 met aquatic life use goals; 29 percent met some goals; and 50 percent did not meet goals. Only 6 percent of sampled sites met the recreation use goals.
